**AVIATION INVESTIGATION REPORT**  
**A03P0239**

**COLLISION WITH TERRAIN**

**CESSNA 210A C-FNTH**  
**PRINCETON, BRITISH COLUMBIA**  
**10 AUGUST 2003**

Report Number A03P0239

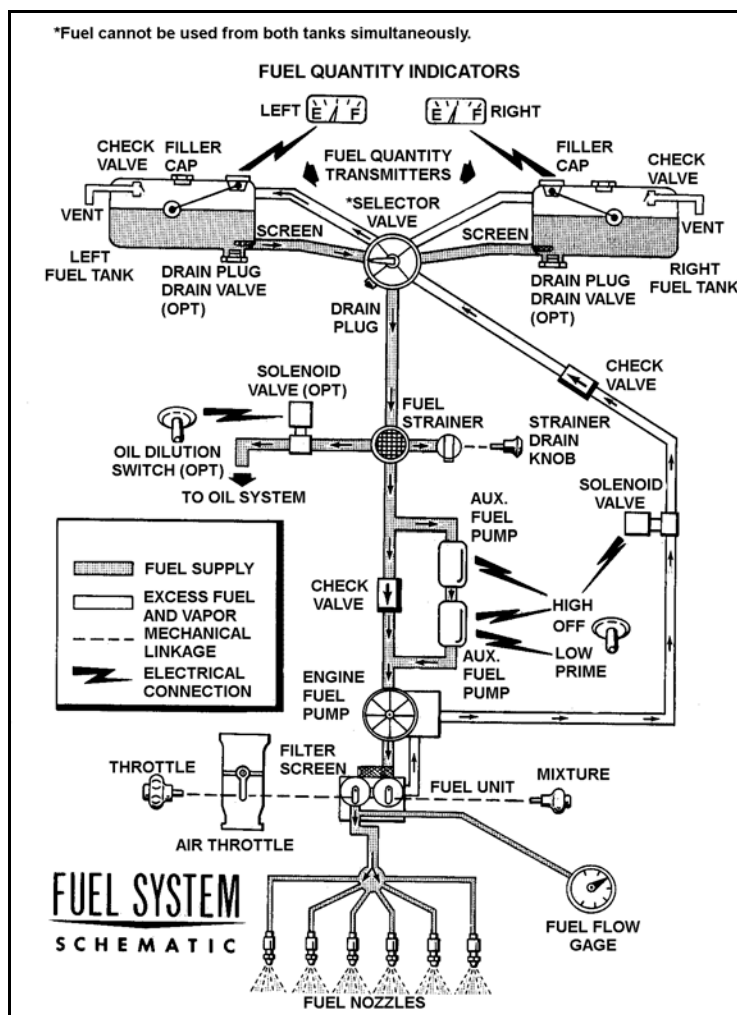
<sup>1</sup> Refer to Figure 1 for the relative location of the various fuel components within the Cessna 210 fuel system.

Figure 1. Cessna 210 Fuel System Schematic
